## Assessment of 20-kW S-Band Transmitter

R. Dickinson and H. Hansen

Radio Frequency and Microwave Subsystems Section

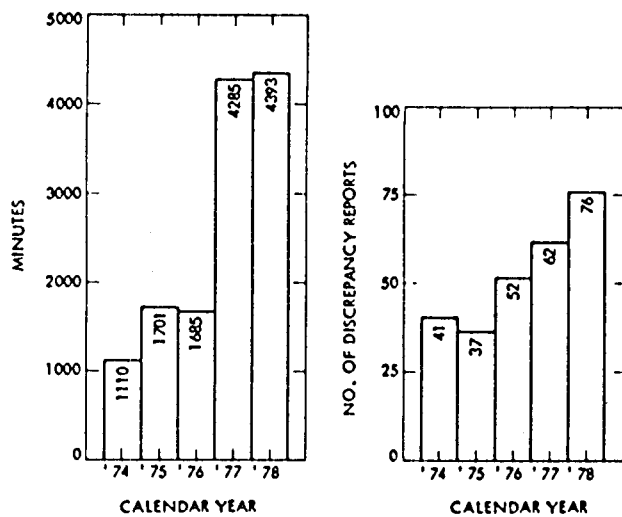
Fig. 1. 20-kW transmitter outage

For the years 1976 through 1978, the outage time illustrated in Fig. 1 was divided among power amplifier (25%), power supply (25%), heat exchanger (25%), miscellaneous (20%) and procedural (5%) sources. Table 1, which describes the reports for 1977, is representative of the failure pattern and shows many of the large outages which were the reason for the sharp rise in 1977.

Note that total outage due to fan failure, cooling system leaks, arc detector tripping, and insulation faults is 3862 minutes, about 90% of the total.

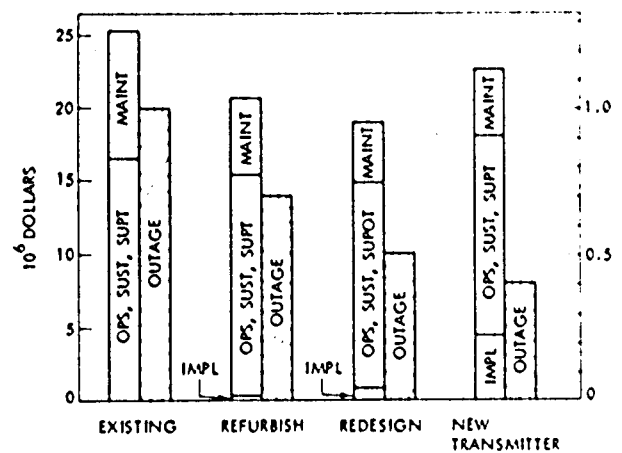
Fig. 2. Relative outage

The result of the estimates and computation of costs for the nine transmitters in the DSN are shown in Table 3 and Fig. 2. As noted above, the computations for Option 4 made allowance for costs of the old transmitter during a three-year design cycle. By way of interest, a computation was made for the new transmitter for FY83 through FY92, i.e., after completion of the design-phase in cycle. These figures, Table 3, make Option 4 especially attractive when charges for the change-over period are deleted.
